SAS Superstructure

Daily Diary Report by Bid Item

Diary #: 121 Const Calendar Day: 347 Date: 21-Aug-2010 Saturday

04-0120F4
04-SF-80-13.2/13.9
Self-Anchored
Suspension Bridge

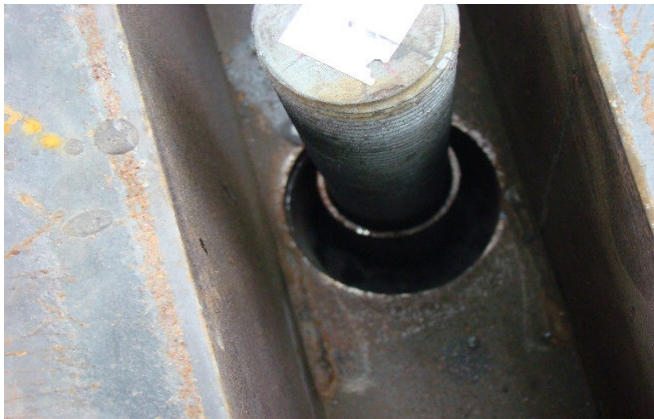
W2E West Deviation Saddle steel forms bearing on the protective pipe sleeve of an anchor rod. It is unknown whether this is "liquid tight" or not.

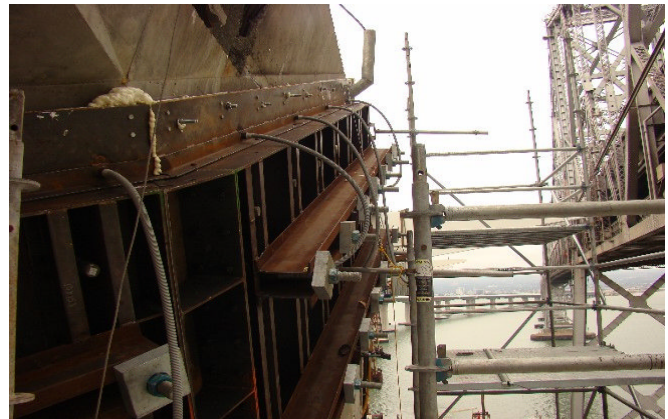
ABF ironworkers installed outlet grout tubes with shut off valves at the top of the steel forms today.
